Manhole Inspection Summary

Manhole # S07EE1003MH

Insp Date: **7/16/09 9:51 AM**

Location Address: **3800 BOARMAN AVE**

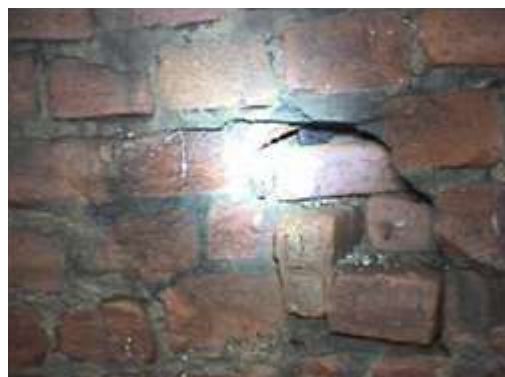
Defect 1

Condition: ☐ Sound ☐ Cracked ☐ Root Intrusion ☒ **Loose Brick** ☒ **Deteriorated**

DETERIORATED BRICKS IN WALL

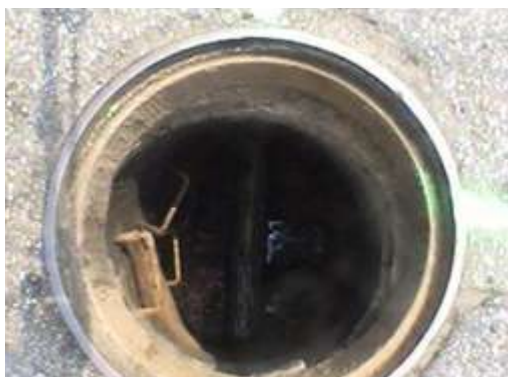
Defect 3

Offset: **3** (in.)

Condition: ☐ Sound ☒ **Cracked** ☐ Leaks

OFFSET FRAME AND CRACK FRAME
CONDITION

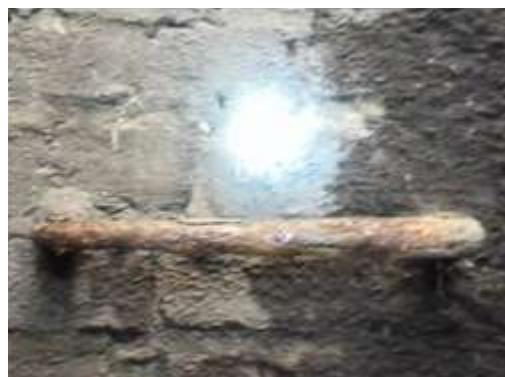
Defect 2

Count: **4** Missing: **0** ☒ **Corroded**

CORRODED RUNG

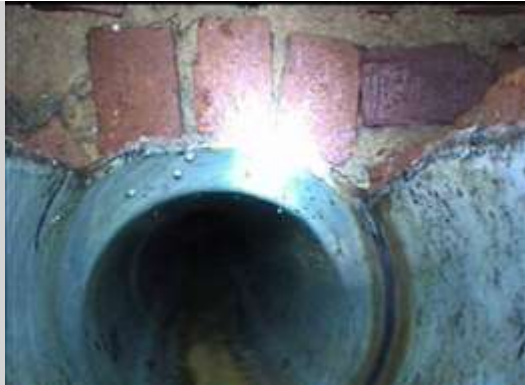
12 O'Clock Outflow

8 in. Circular Gravity Sewer
Pipe Out @ 12 O'Clock

Pipe Height: (in.) Direct
Pipe Material: **PVC** ☐ Pipe Lined
Invert Depth: **9.42** (ft.) Flow Characteristics: **Slow**
Deposits: ☒ None ☐ Mud ☐ Sludge ☐ Debris ☐ Grease
Silt Depth: (in.) Deposits Extent:
Infiltration: **None** Pipe Seal Cond: **Sound**

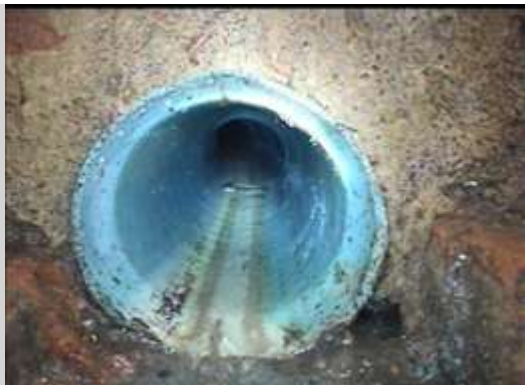
3 O'Clock Inflow

8 in. Circular Gravity Sewer
Pipe In @ 3 O'Clock

Pipe Height: (in.) Direct
Pipe Material: **PVC** ☐ Pipe Lined
Invert Depth: **8.88** (ft.) Flow Characteristics: **Slow**
Deposits: ☒ None ☐ Mud ☐ Sludge ☐ Debris ☐ Grease
Silt Depth: (in.) Deposits Extent:
Infiltration: **None** Pipe Seal Cond: **Sound**

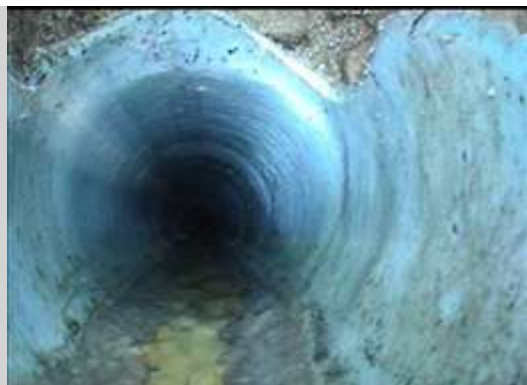
6 O'Clock Inflow

8 in. Circular Gravity Sewer
Pipe In @ 6 O'Clock

Invert Depth: **9.00** (ft.) Flow Characteristics: **Slow**

Infiltration: **None** Pipe Seal Cond: **Sound**
